From Rail Commuters to Autonomous Vehicles – Guastavino Vaulted Ceilings Have You Covered

TMS FALL MEETNG
DENVER COLORADO
OCTOBER 12, 2022

Tom Elliott
Director of Industry
Development/Technical Services
International Masonry Institute-IMI

MICHIGAN CENTRAL STATION

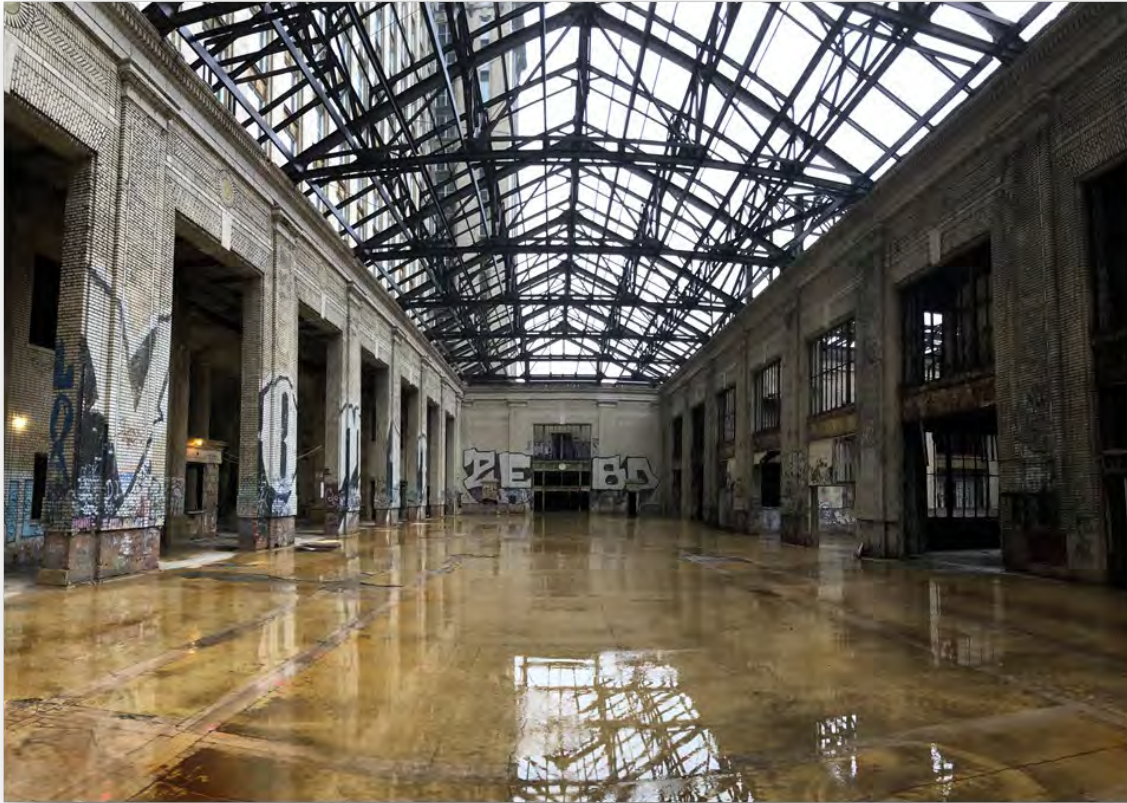
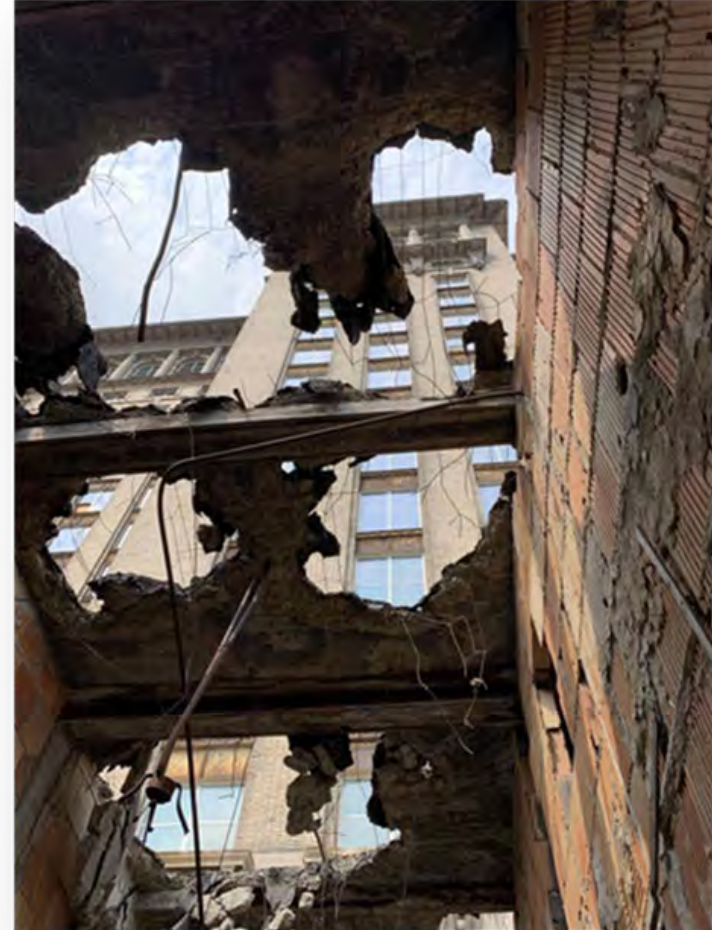
Moisture

The largest single factor to MCS's condition

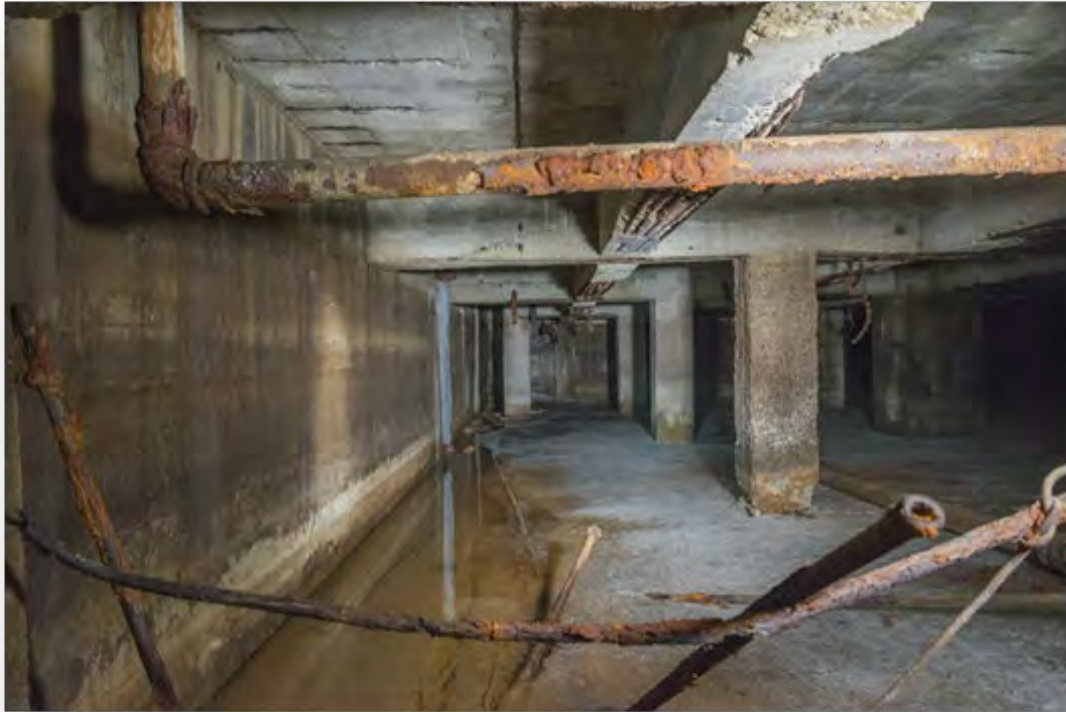
Water removal

Five foot or more of standing water in lower level

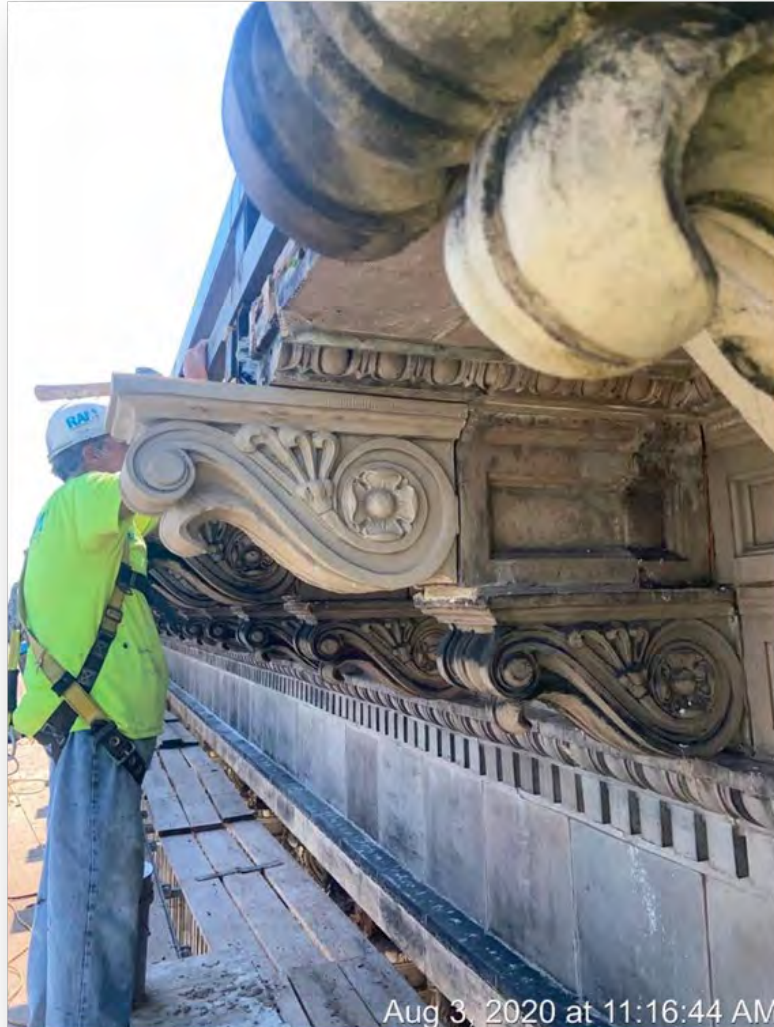
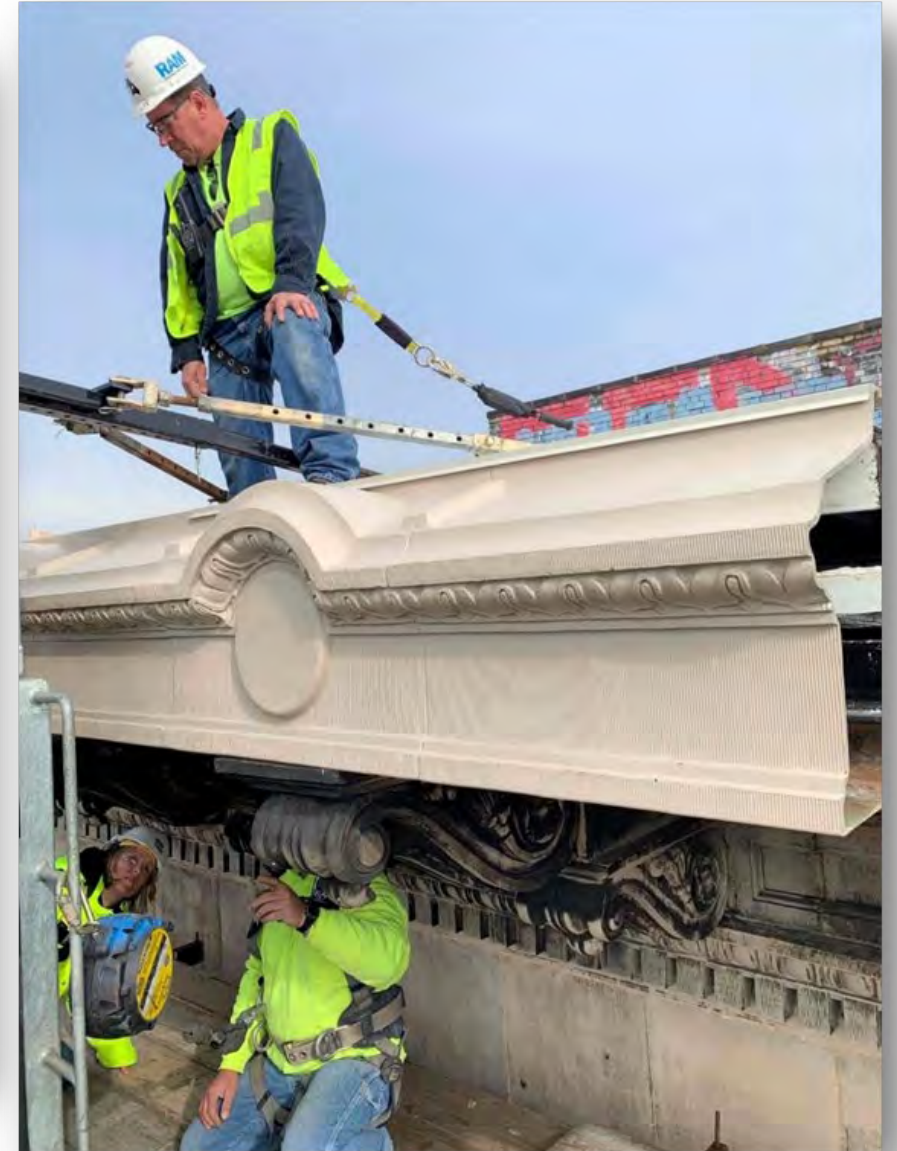
Terra Cotta-Glass fiber reinforced plastic

- Severe damage
- Elements removed in 80's
- Terra Cotta replaced with GFRC
- Terra cotta lead times

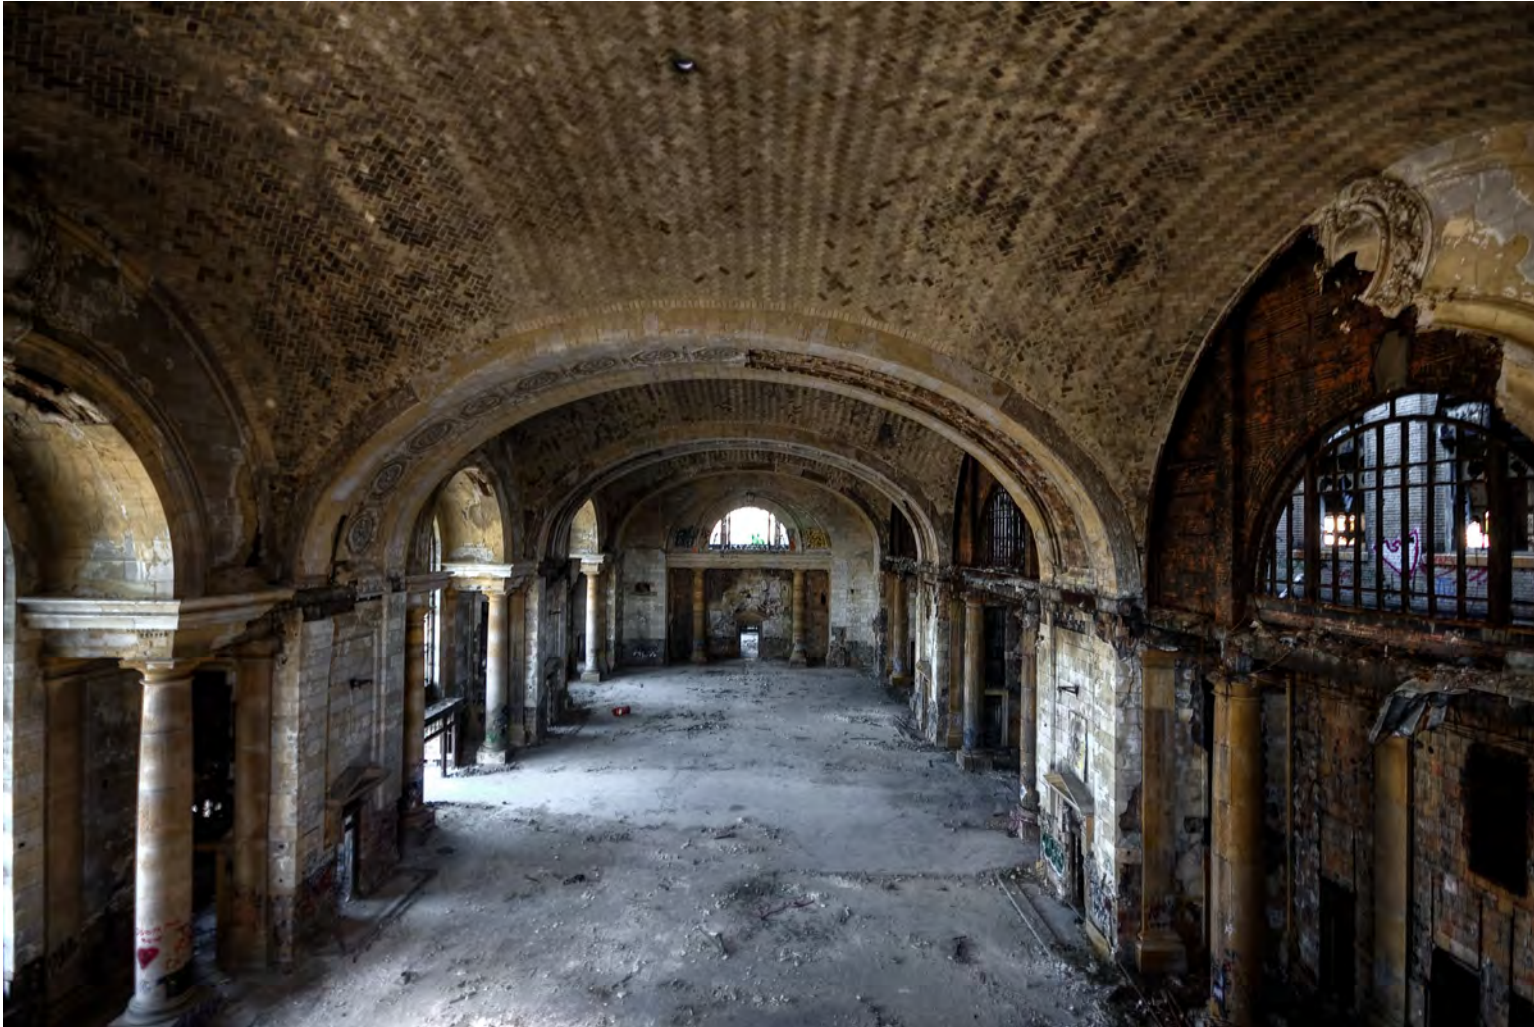
Guastavino vaulted ceiling waiting room

- Undermaintained
- Loose tiles
- Missing mortar
- No structural damage to the expose bottom side

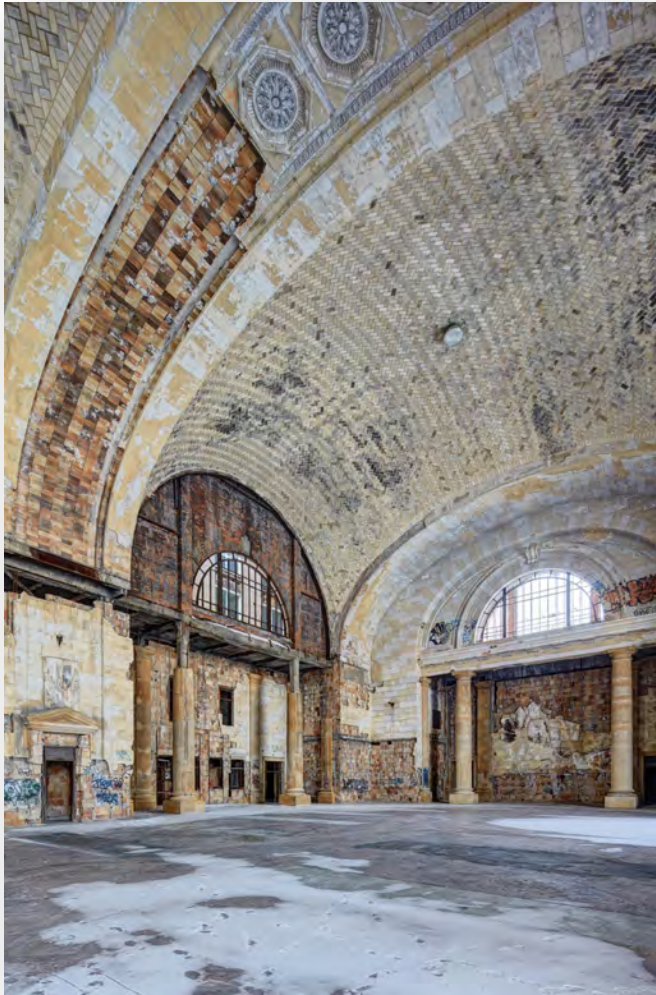
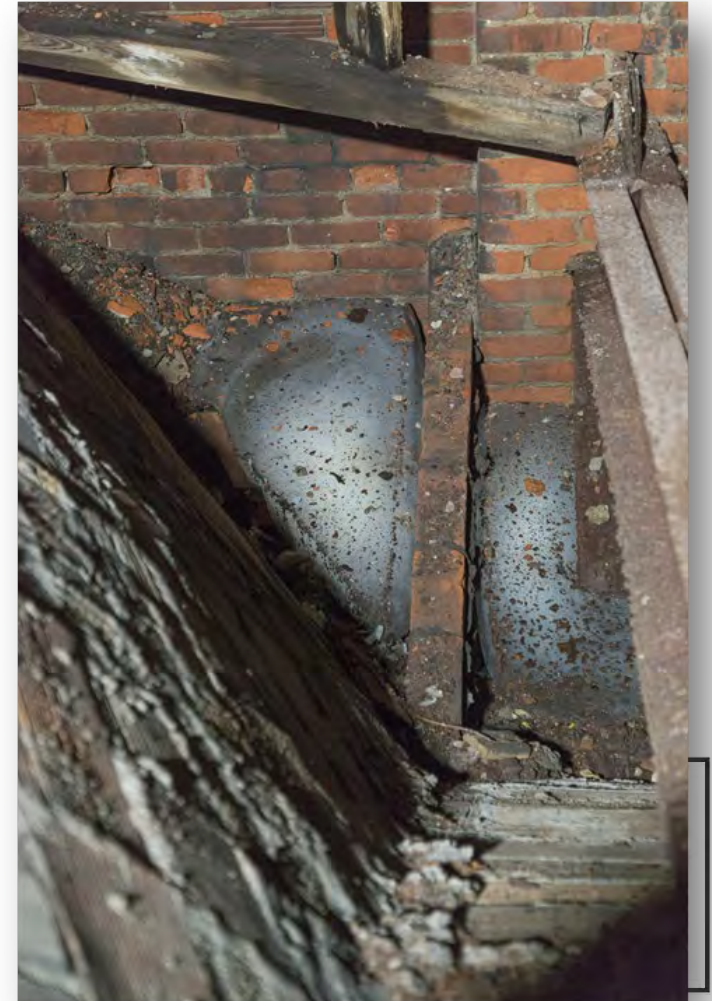
GUASTAVINO DOME ICE PACKS

- “Perma frost” found on top side of ceiling
- Severe in lower areas
- Melting ice well after May
- Areas with several feet of ice
- Extreme damage to steel

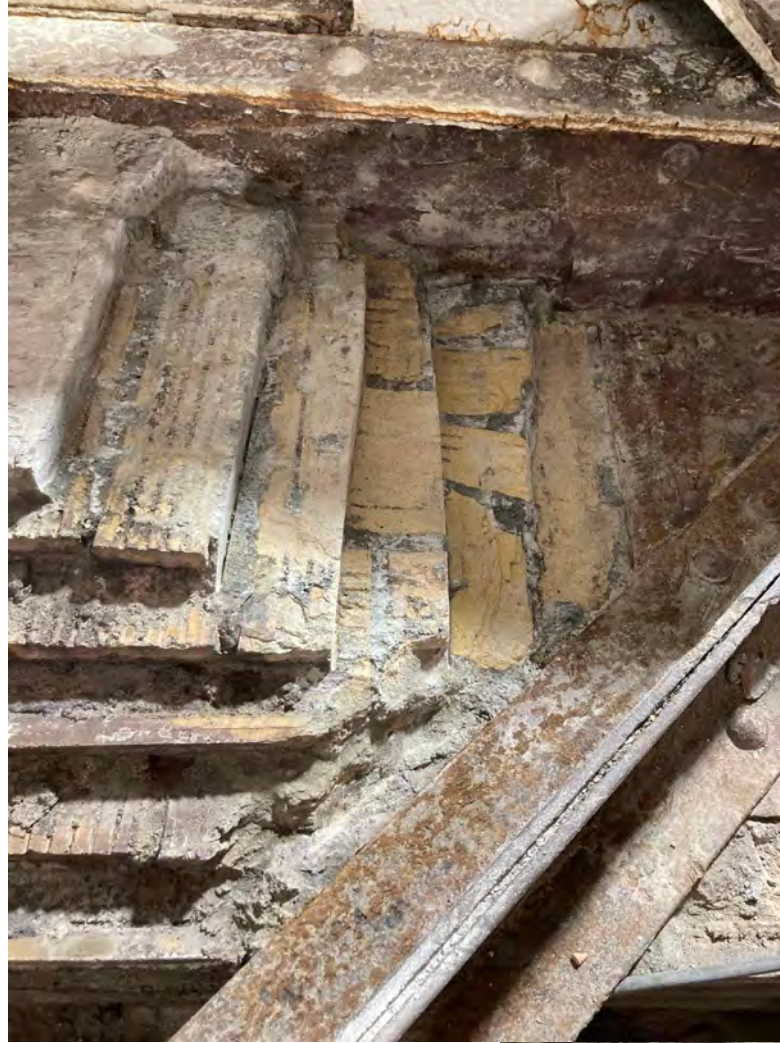
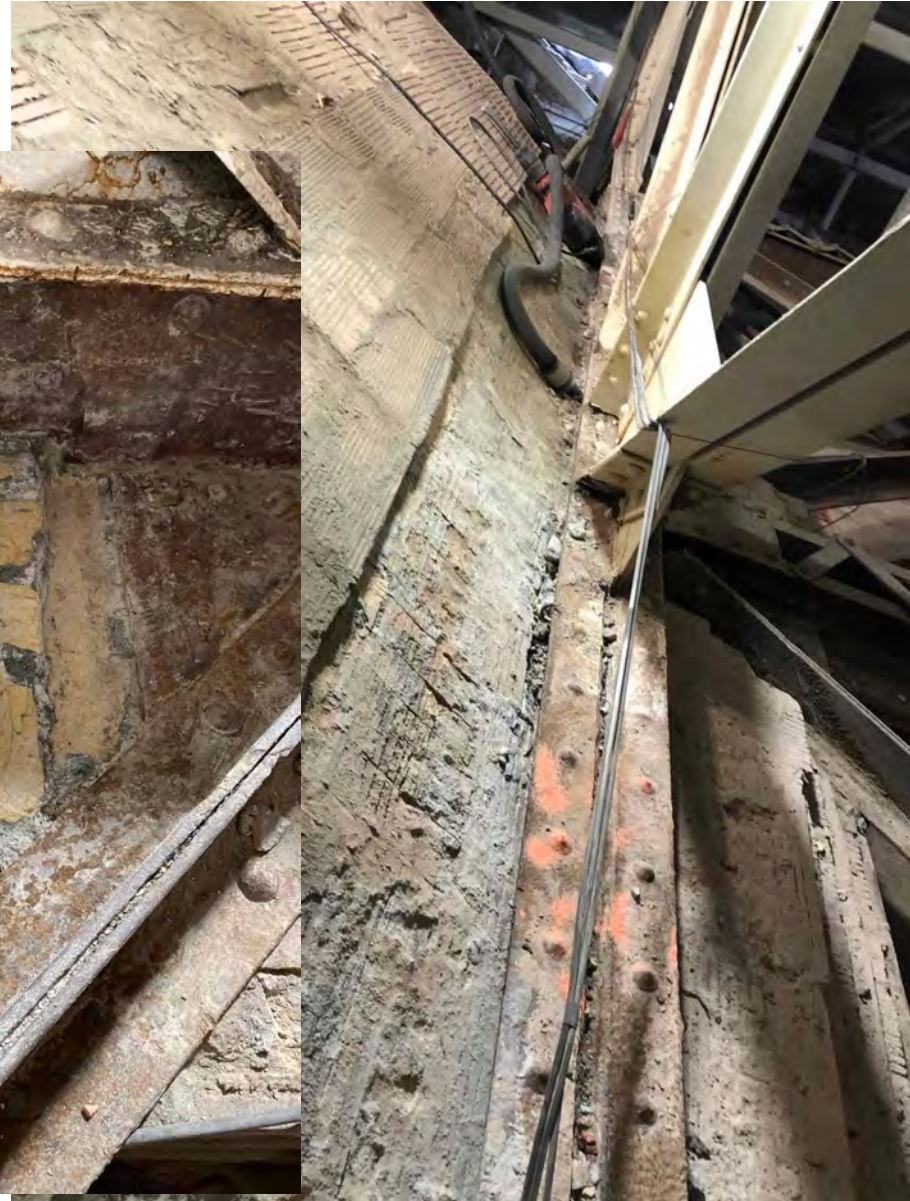
TOP SIDE REPAIRS

- Deteriorated tiles
- Steel exposed
- Prepped for painting crews
