# Nondestructive Evaluation of Stone Anchor Corrosion Effects

2022 Annual Meeting  
Denver, CO  
October 13, 2022

Torin McCue  
Engineer Intern III

Atkinson-Noland & Associates  
[www.ana-usa.com](http://www.ana-usa.com)

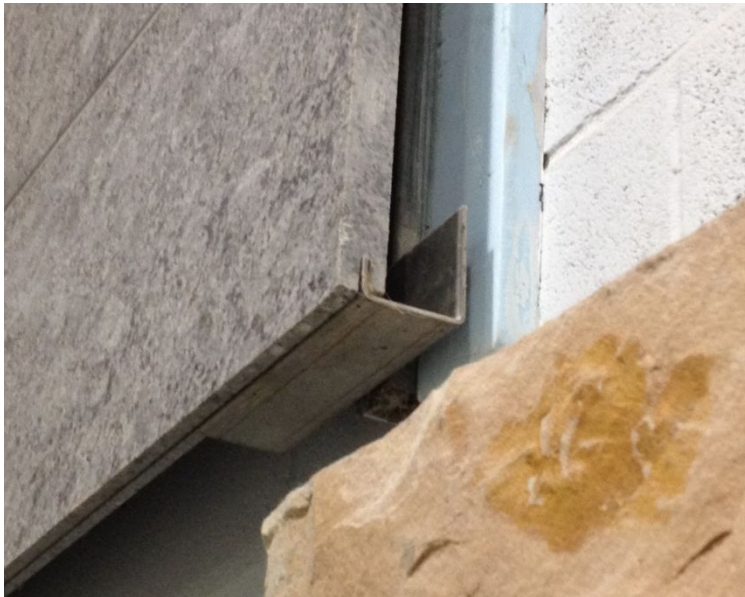
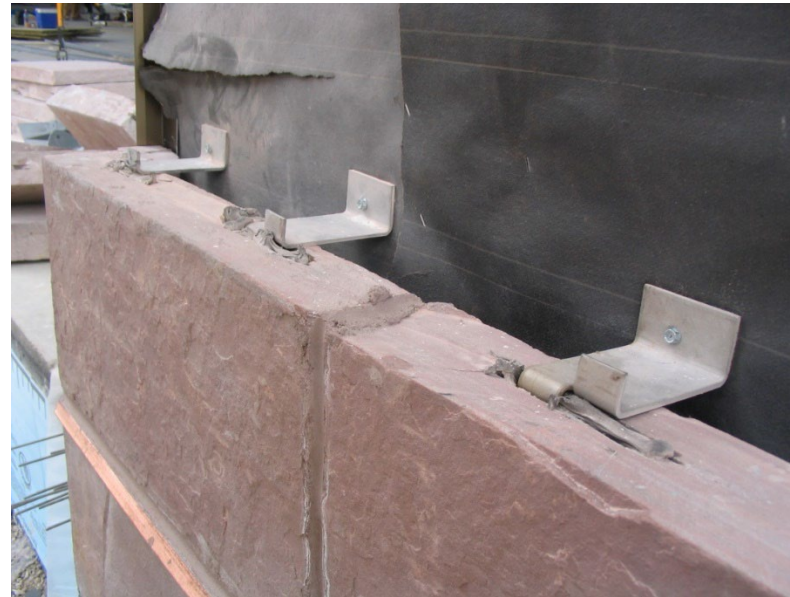
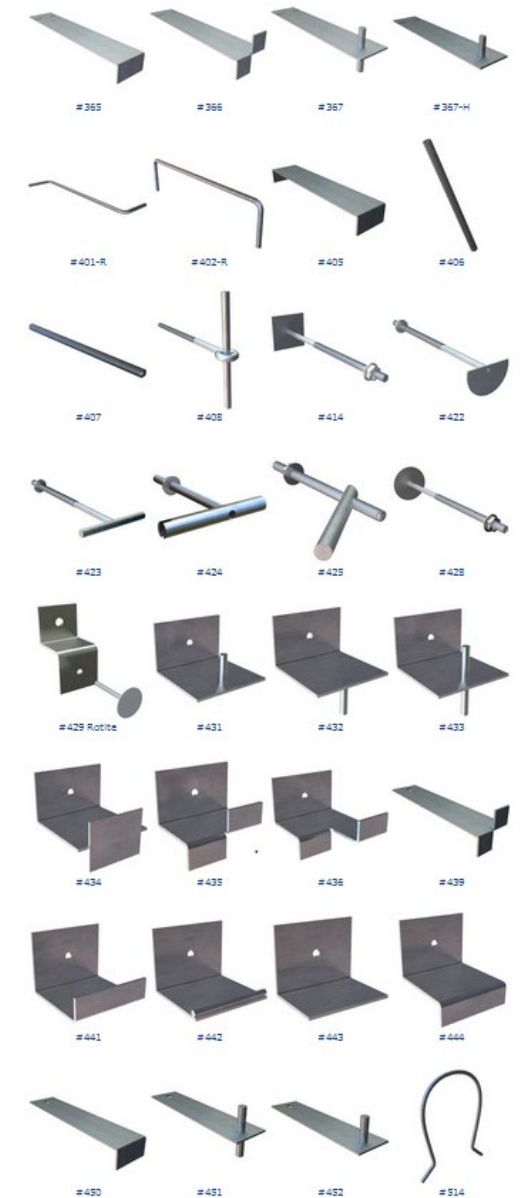
- Common detail for exterior building envelopes
- **Modern** and historic constructions

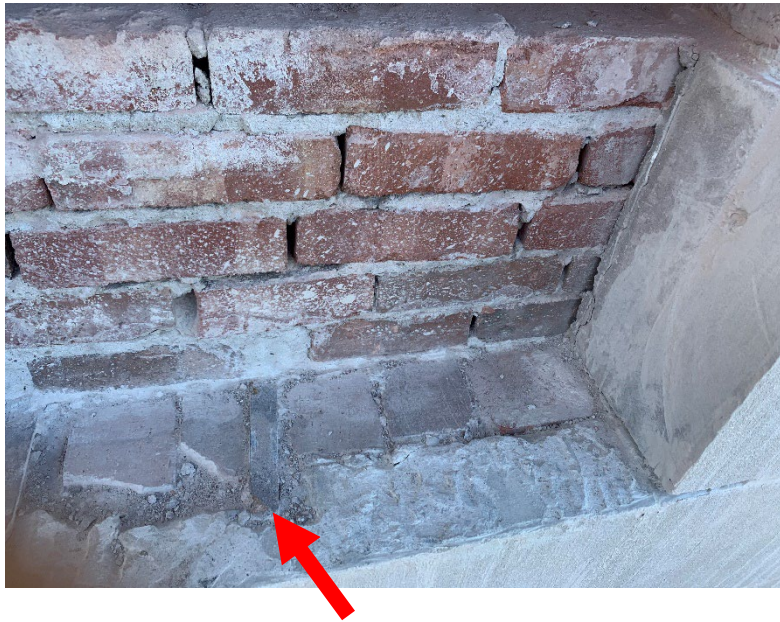
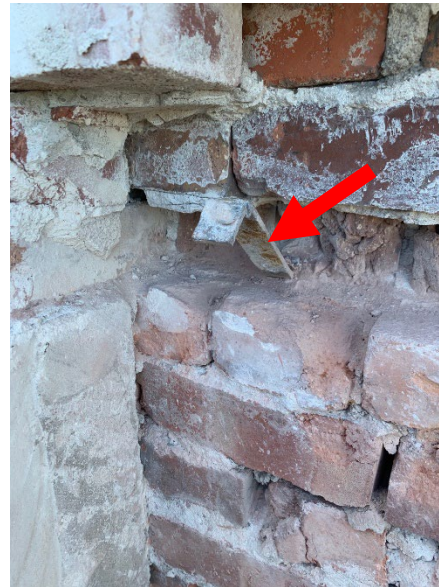
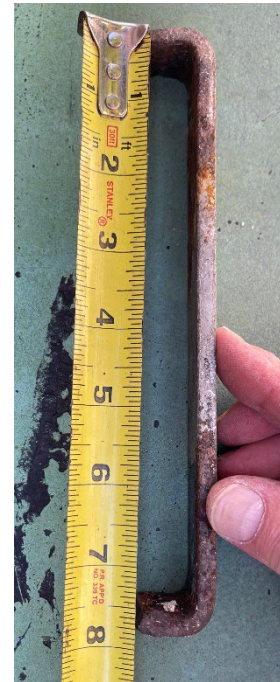
- Common detail for exterior building envelopes
- Modern and **historic** constructions

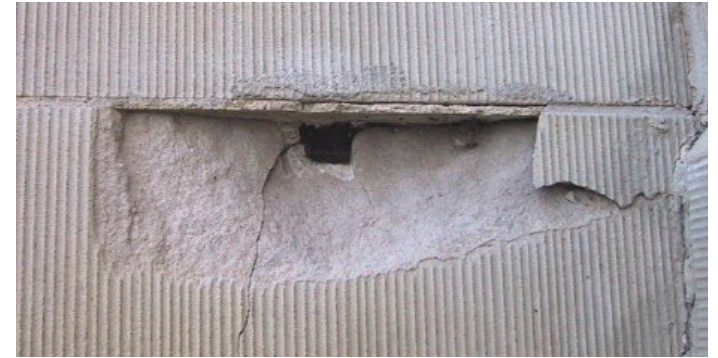
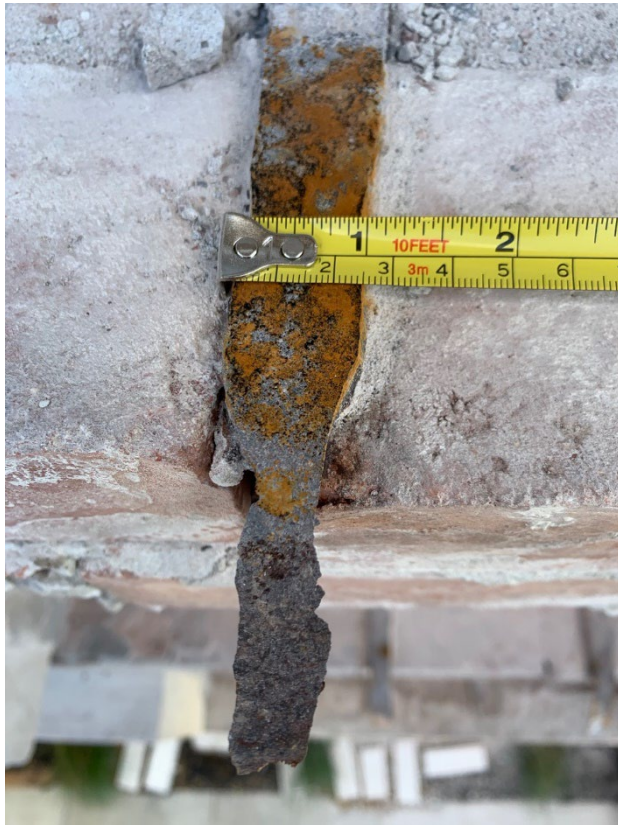
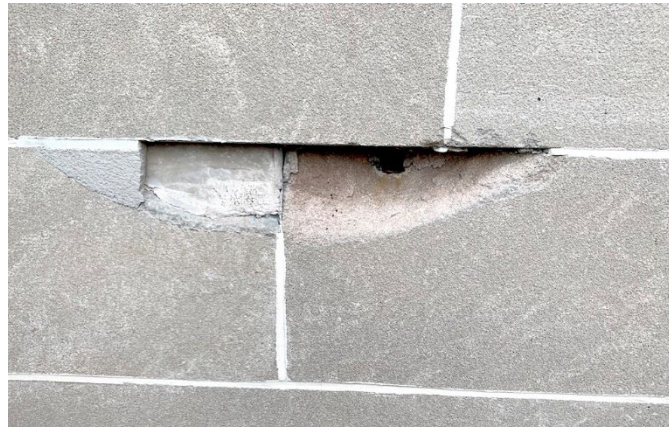
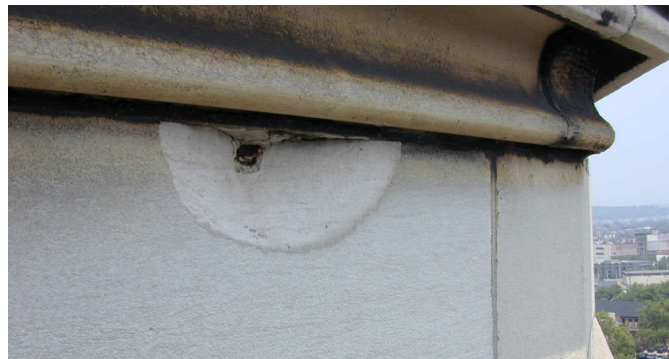
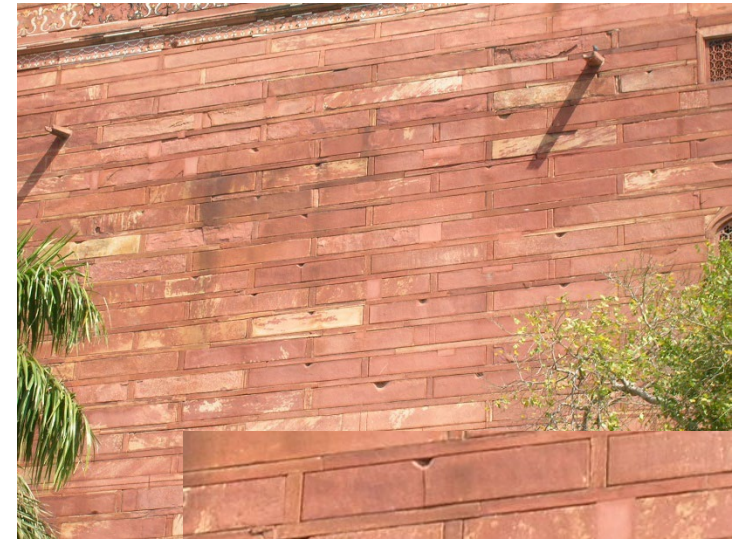
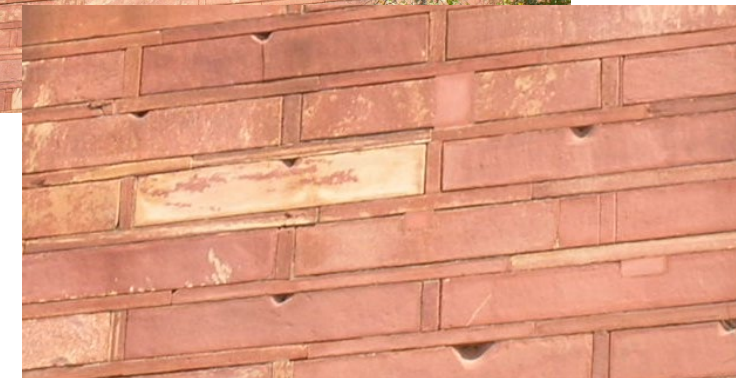
- Corrosion related spalls at embedded anchors

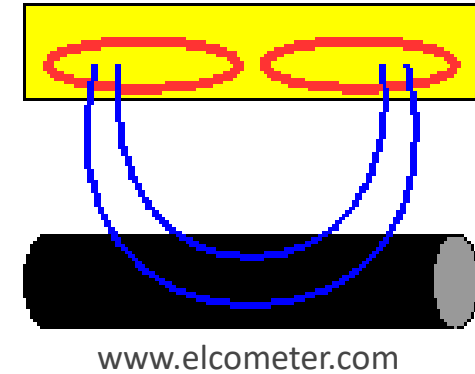
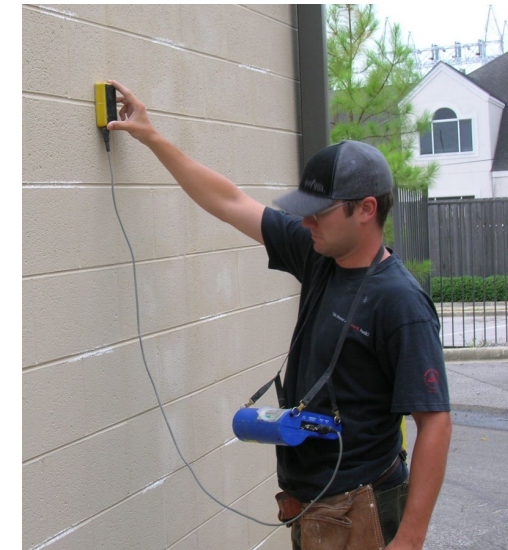
- Simplest: eddy-current pachometer scanning
  - Pulse induction method
  - Detects any conductive metal

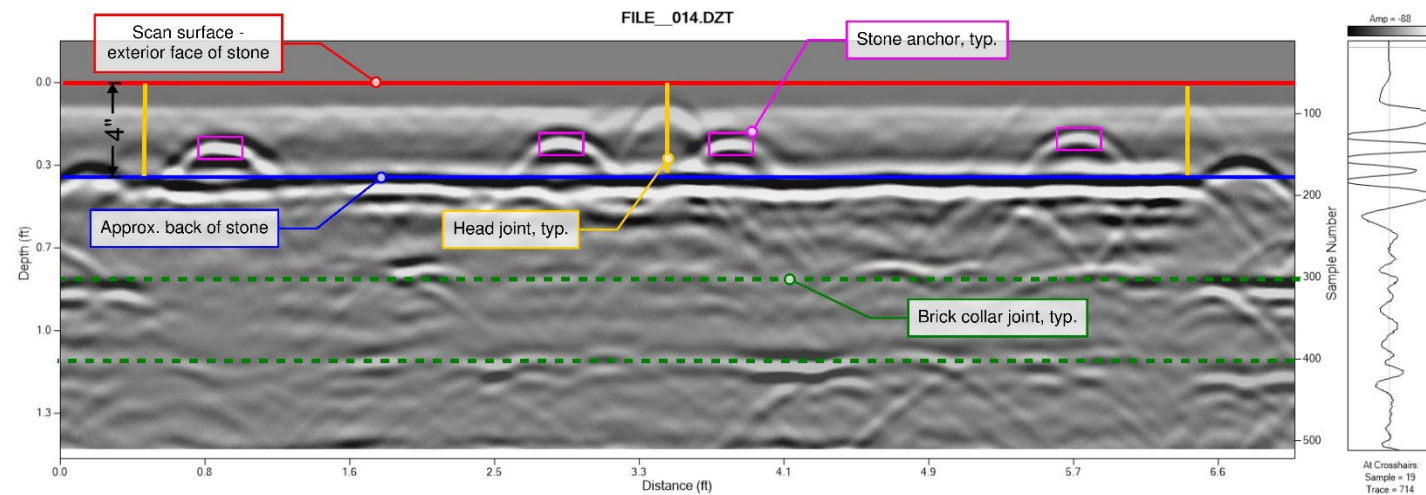
- More detail: surface penetrating radar
  - High frequency electromagnetic radio (radar) pulses
  - Detects any change in wave speed

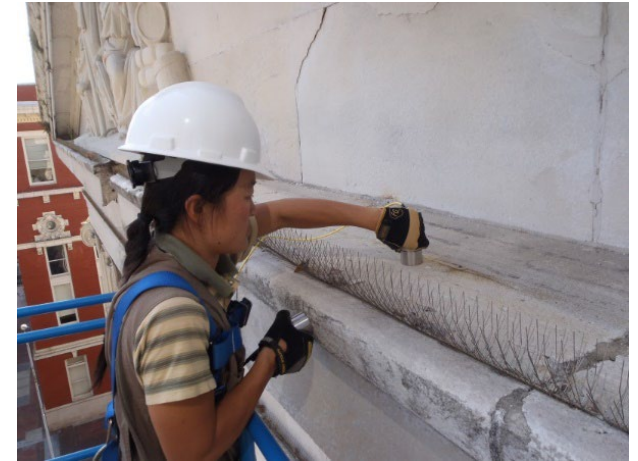
- Ultrasonic Pulse Velocity (UPV) & Impact Echo (IE):
  - Direct or “through” transmission
  - Used for years
- Limitations:
  - One pair of transducers = single ray path
  - Tomography is time intensive

$$\text{Pulse Velocity} = \frac{\text{path length}}{\text{travel time}}$$

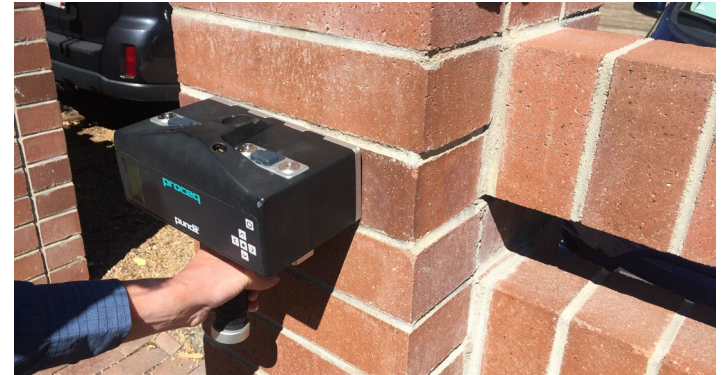
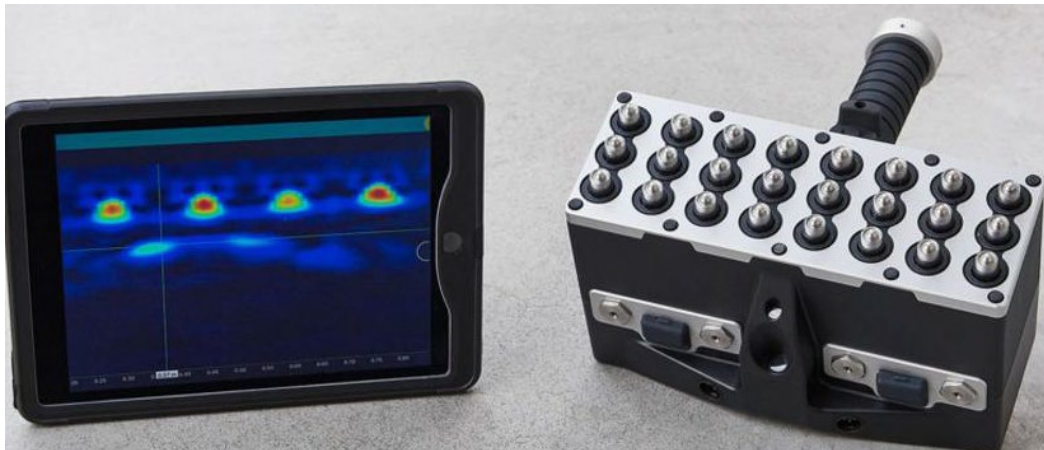
- Ultrasonic Pulse-Echo (UPE):
  - Array of 24 dry-contact transducers pulsing 50 kHz shear wave
  - SAFT algorithm converts travel times into B-scan (2D scan)
    - Essentially real-time tomography combing multiple A-scans (1D scans)
    - Based on time and not frequency like IE

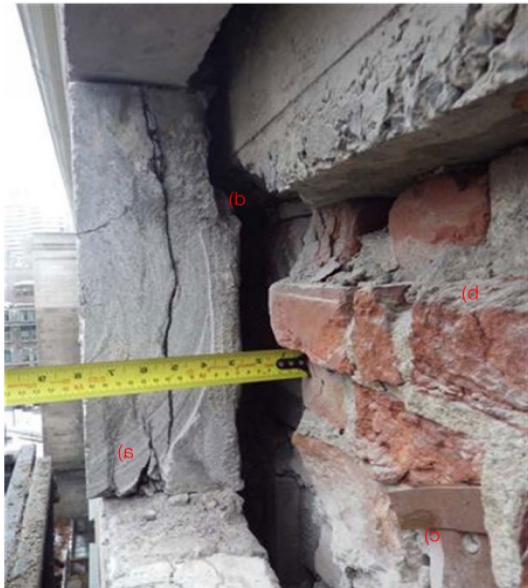
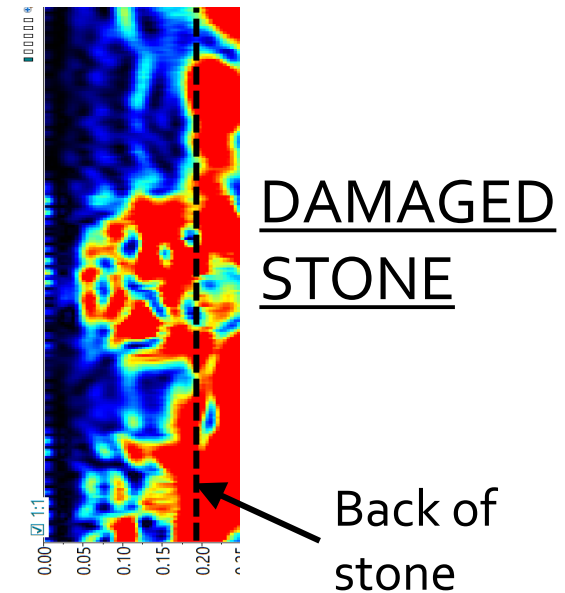
- Typical applications:
  - Thickness of solid substrate (typ. concrete or stone)
  - Homogeneity of concrete or masonry – honeycombing, voiding, internal cracking, etc.
  - Detection of separation or poor bond between substrate and repair (patch)
  - Stone anchor locating - qualitative look at face spalling due to rust jacking

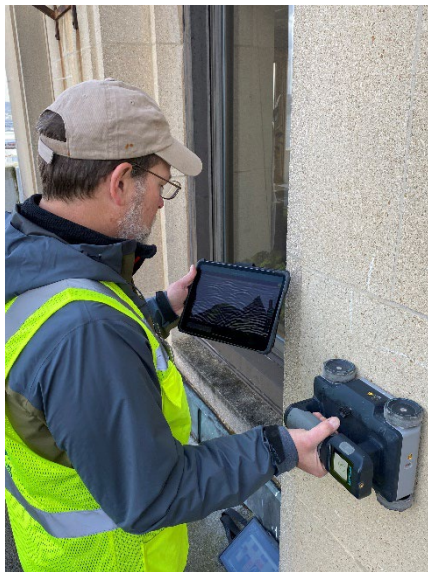
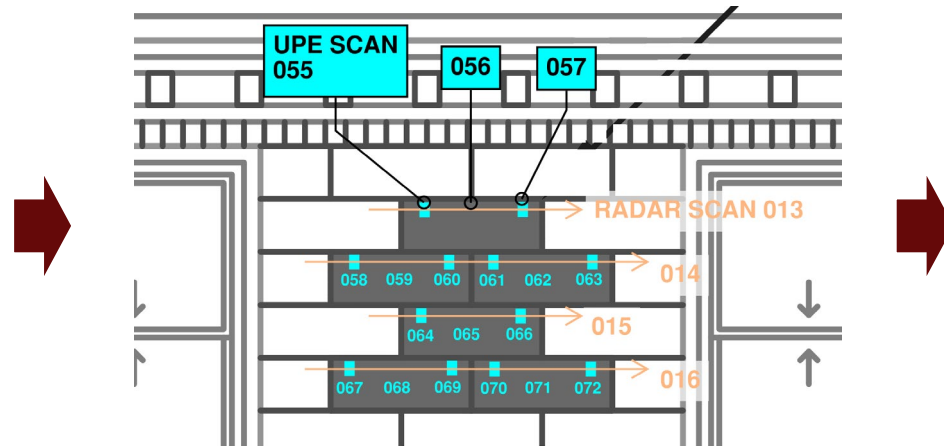
1. Use pachometer and surface penetrating radar to locate stone anchors
2. Mark out location, approx. size, depth of each anchor
3. Collect 'control' scan adjacent to anchor
4. Collect 'test' scan at anchor

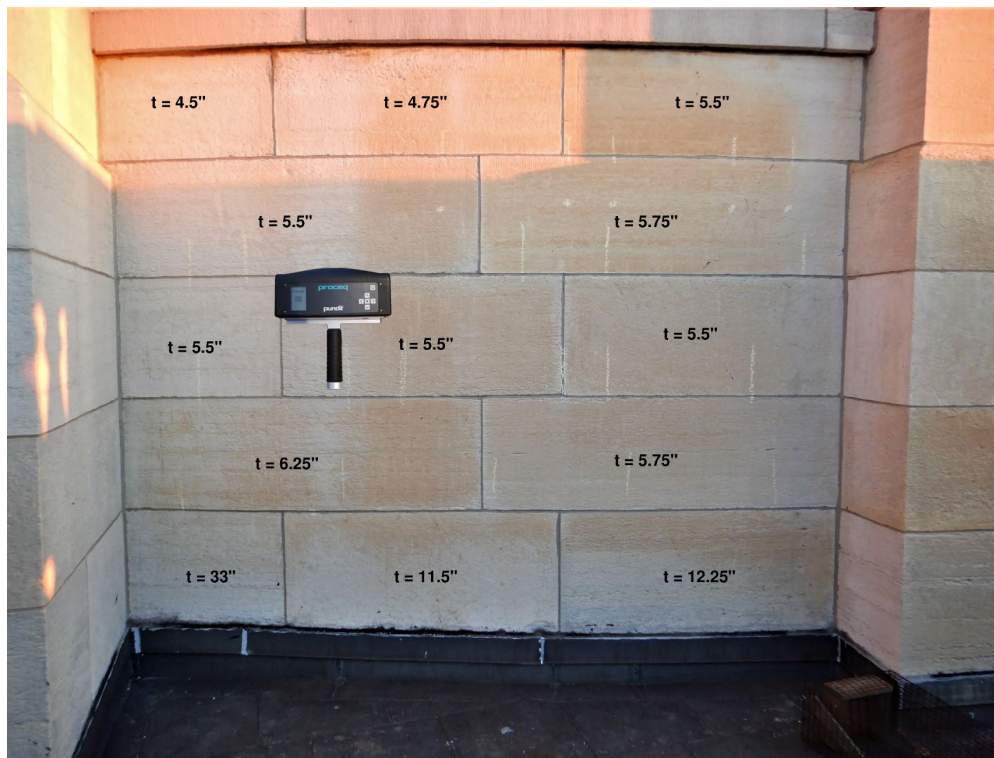
1. In the field or in the office compare 'control' scan with 'test' scan at each anchor location

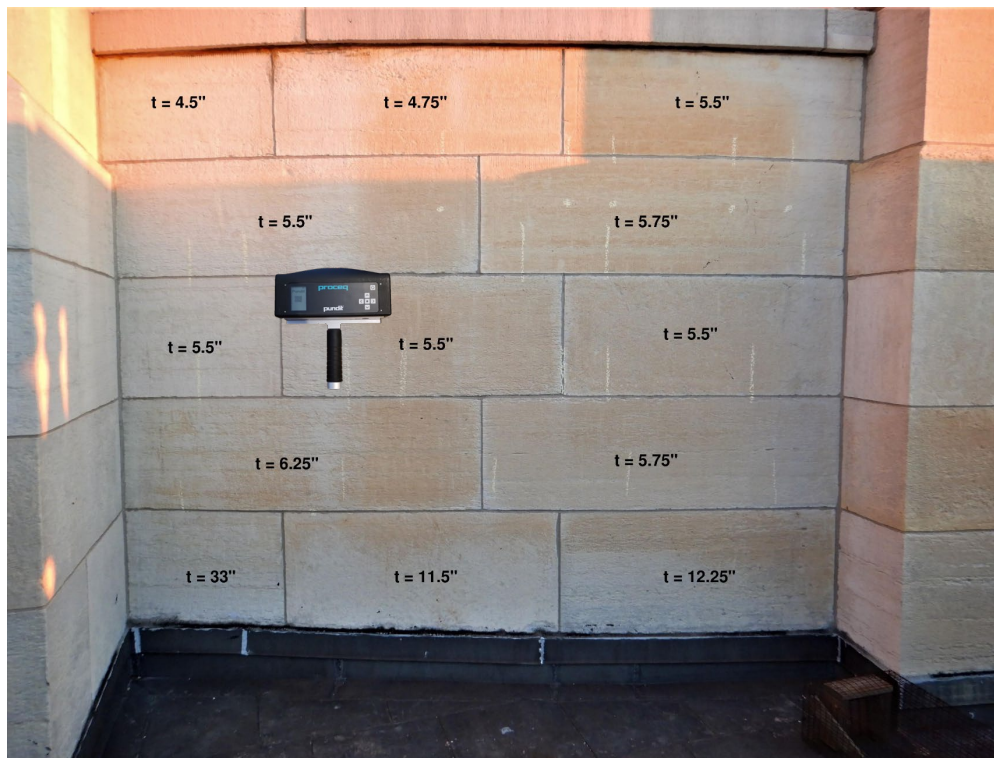
1. In the field or in the office compare 'control' scan with 'test' scan at each anchor location

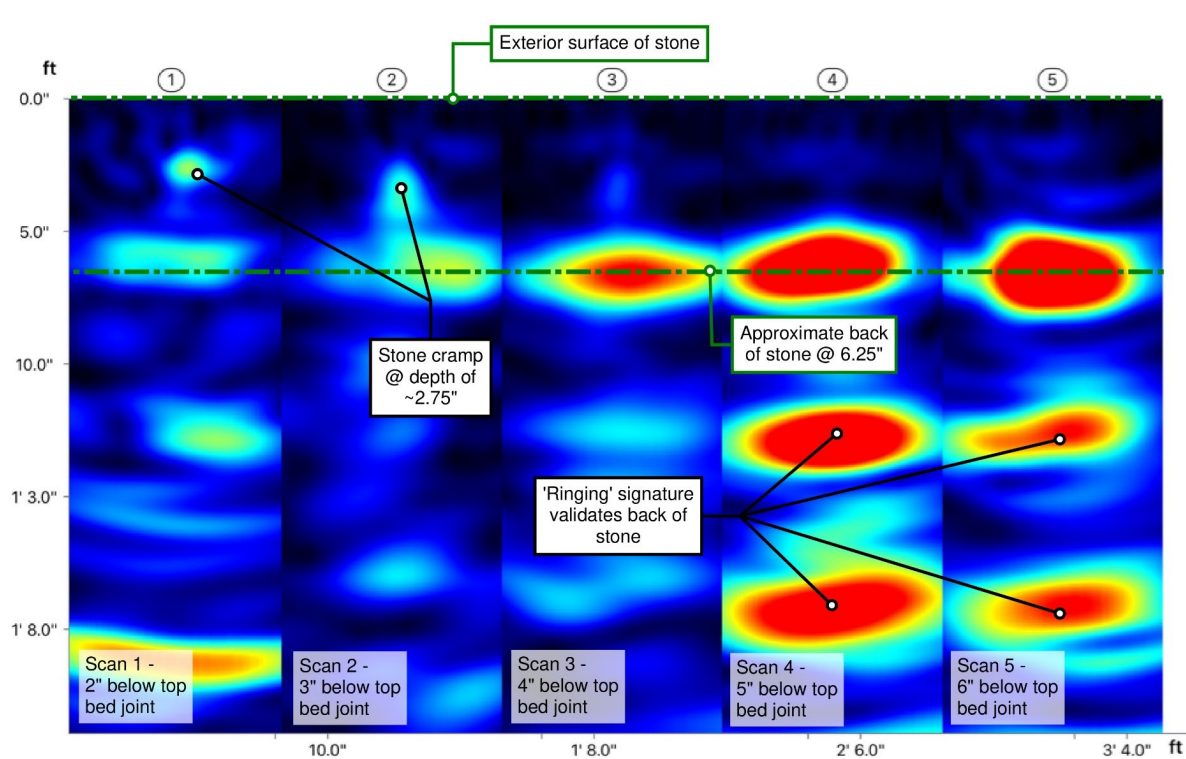
1. In the field or in the office compare 'control' scan with 'test' scan at each anchor location

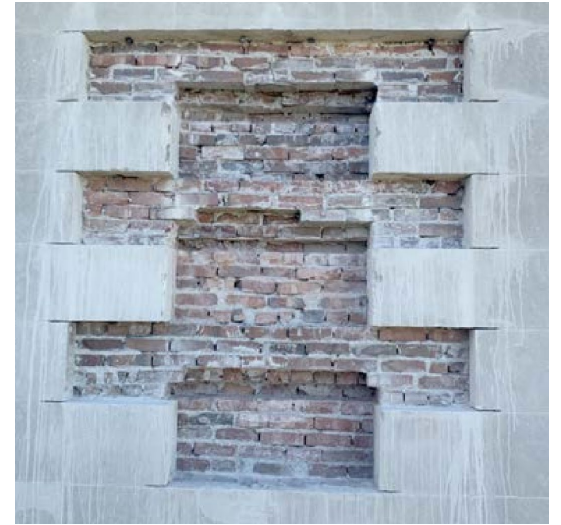
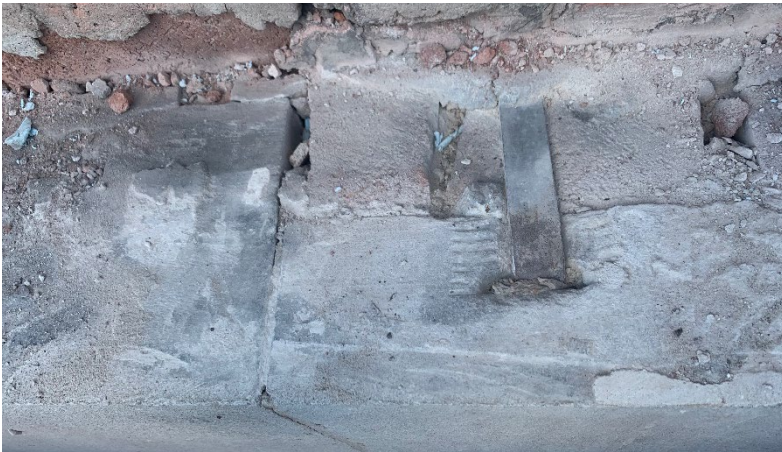
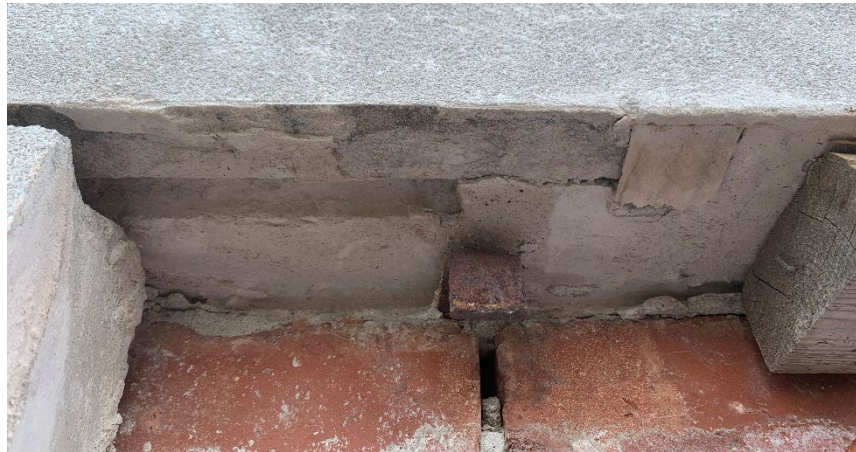
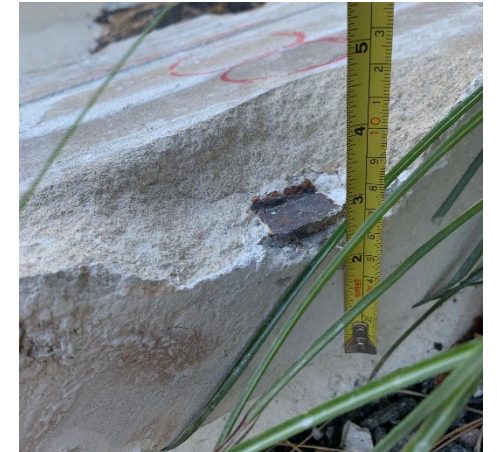
1. Eighteen (18) stone units were removed
  - 100% NDE results correct (thickness)
2. Sixteen (16) anchors were located via the probes
  - 75% NDE results correct (anchor)
3. UPE results were varied – see next slide

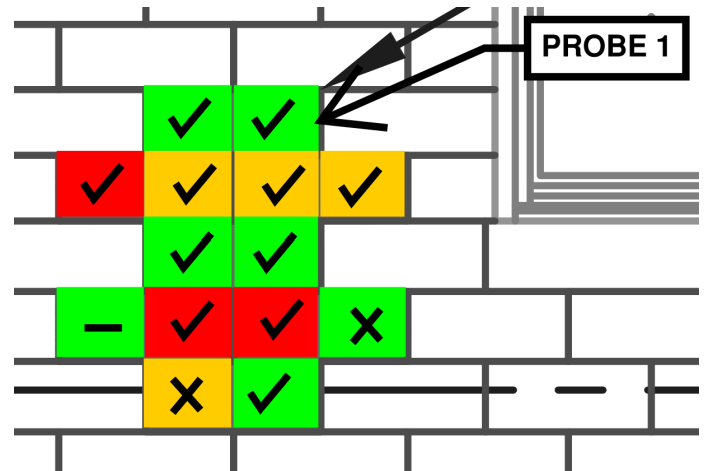
- ✓ NDE RESULTS AGREE WITH RESULTS FROM PROBE OPENING
- DATA FROM PROBE OPENINGS INCONCLUSIVE FOR DETERMINATION OF STONE CONDITIONS
- ✗ NDE RESULTS DO NOT AGREE WITH RESULTS FROM PROBE OPENING
- NO STONES REMOVED - NO COMPARISON

- NO DAMAGE DETECTED
- POTENTIAL CRACKING
- CRACKING DETECTED

- The eddy-current pachometer and SPR need to be used together
  - Could reduce false positives (empty kerfs, missing anchors)
- Videoscoping would be beneficial
- Calibrating UPE interpretations **concurrent** with probe removals would help greatly
