From Rail Commuters to Autonomous Vehicles – Guastavino Vaulted Ceilings Have You Covered

TMS FALL MEETNG
DENVER COLORADO
OCTOBER 12, 2022

Tom Elliott
Director of Industry
Development/Technical Services
International Masonry Institute-IMI

MICHIGAN CENTRAL STATION

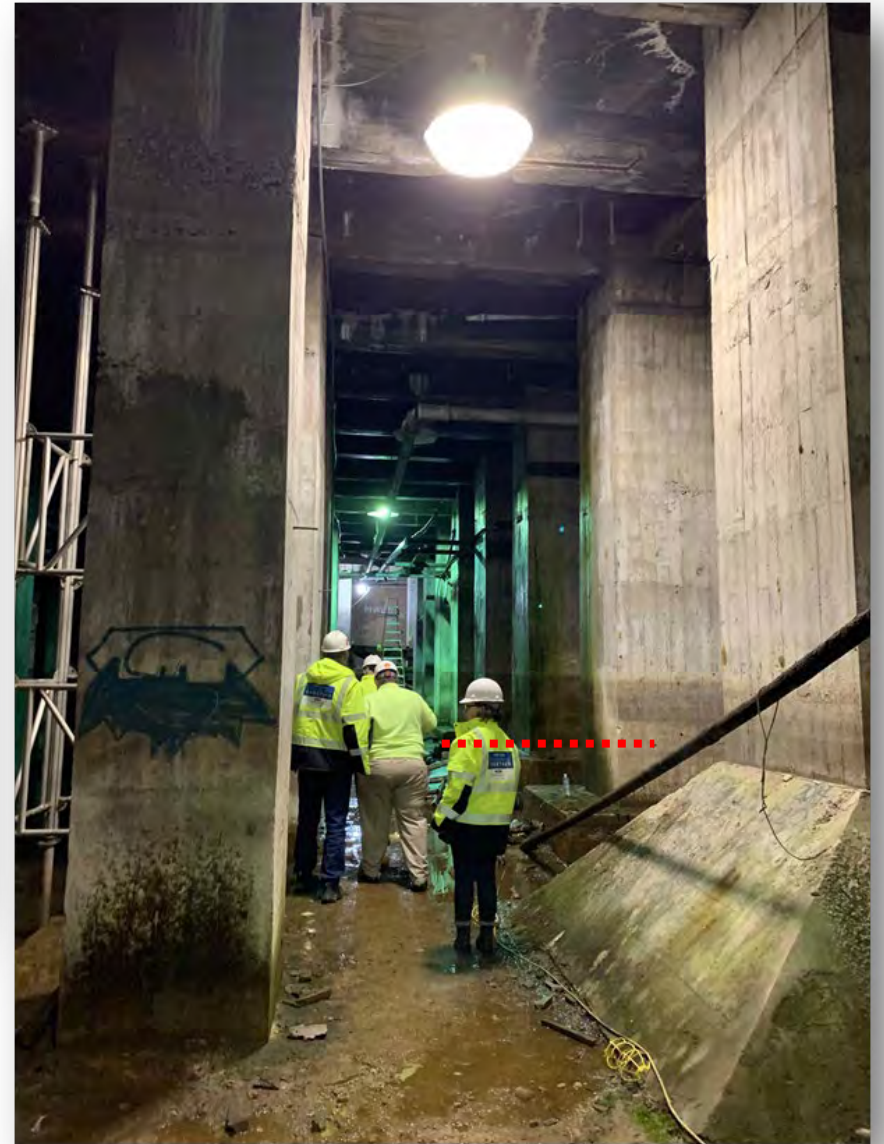
Five foot or more of standing water in lower level

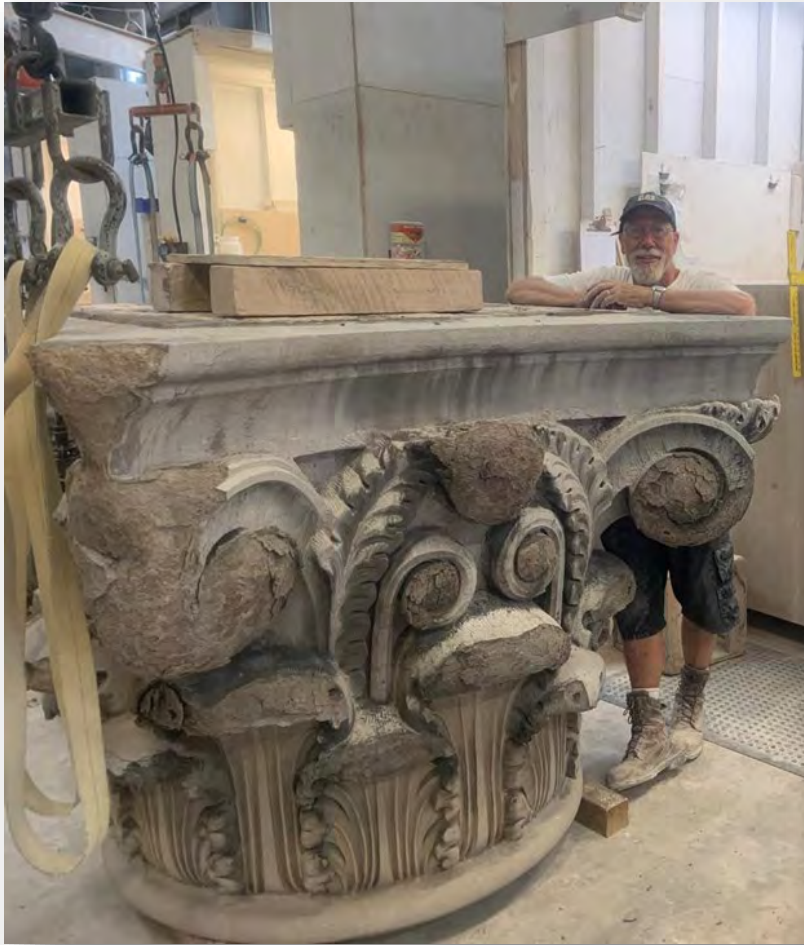
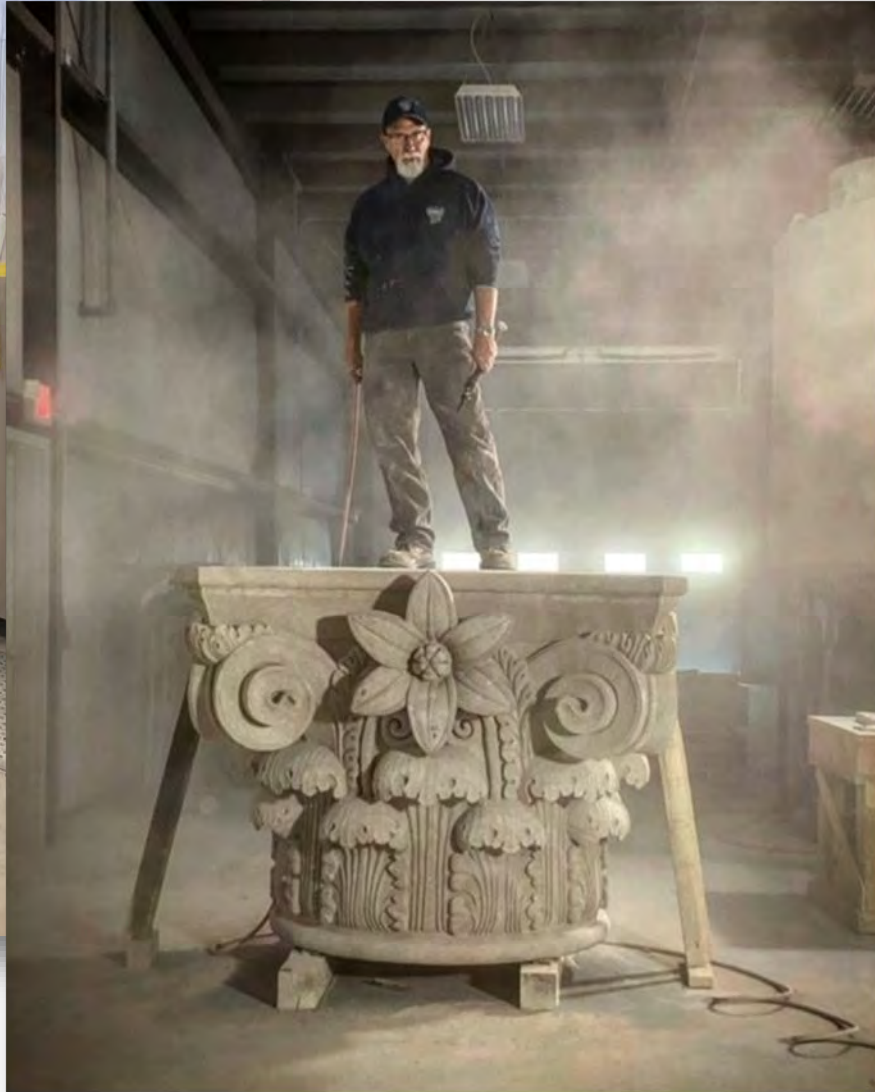
One single 7-ton block of stone – 440 craftsman-hours

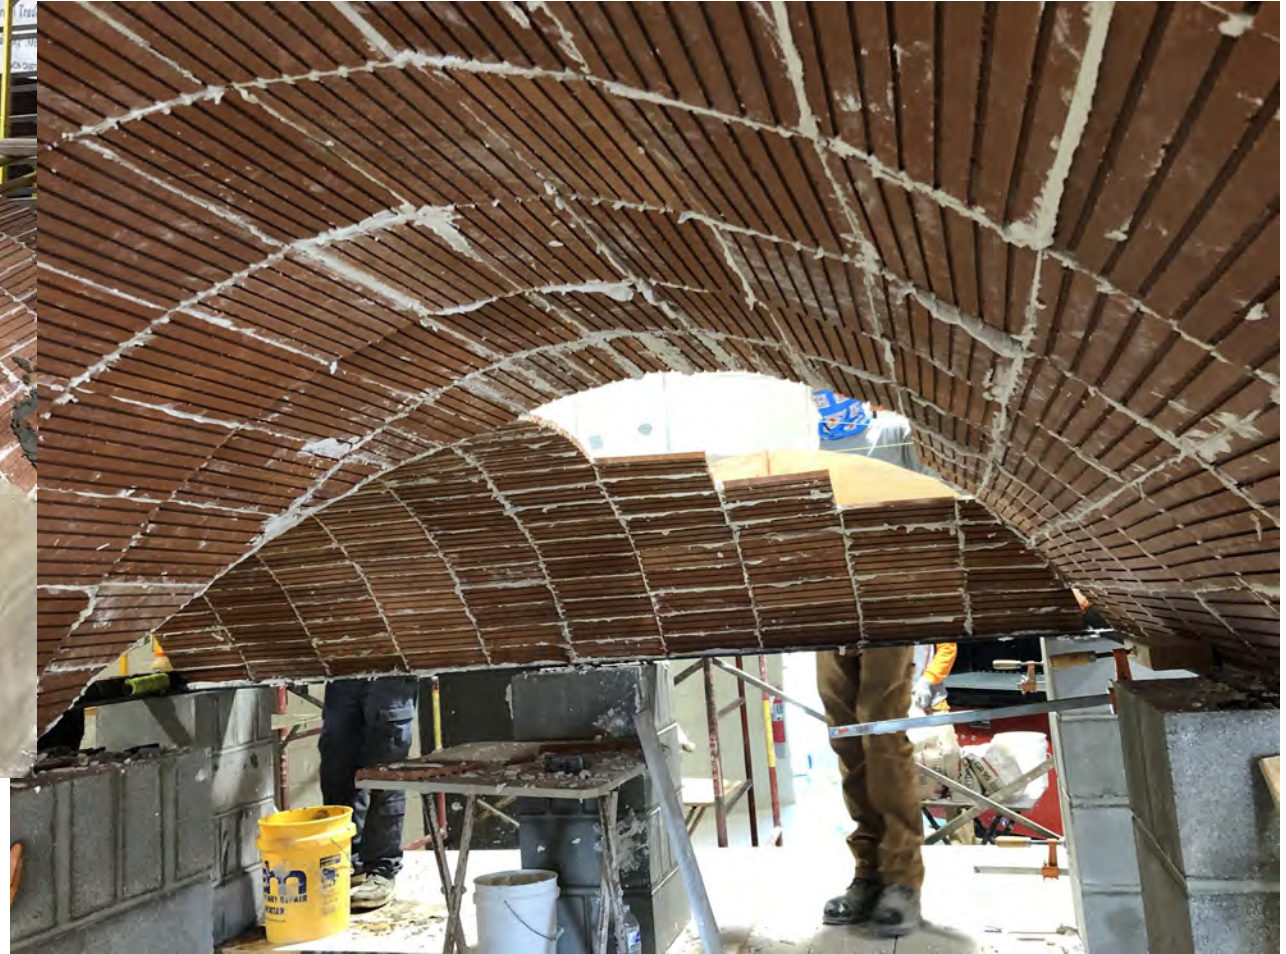
Guastavino vaulted ceiling waiting room

- Undermaintained
- Loose tiles
- Missing mortar
- No structural damage to the expose bottom side

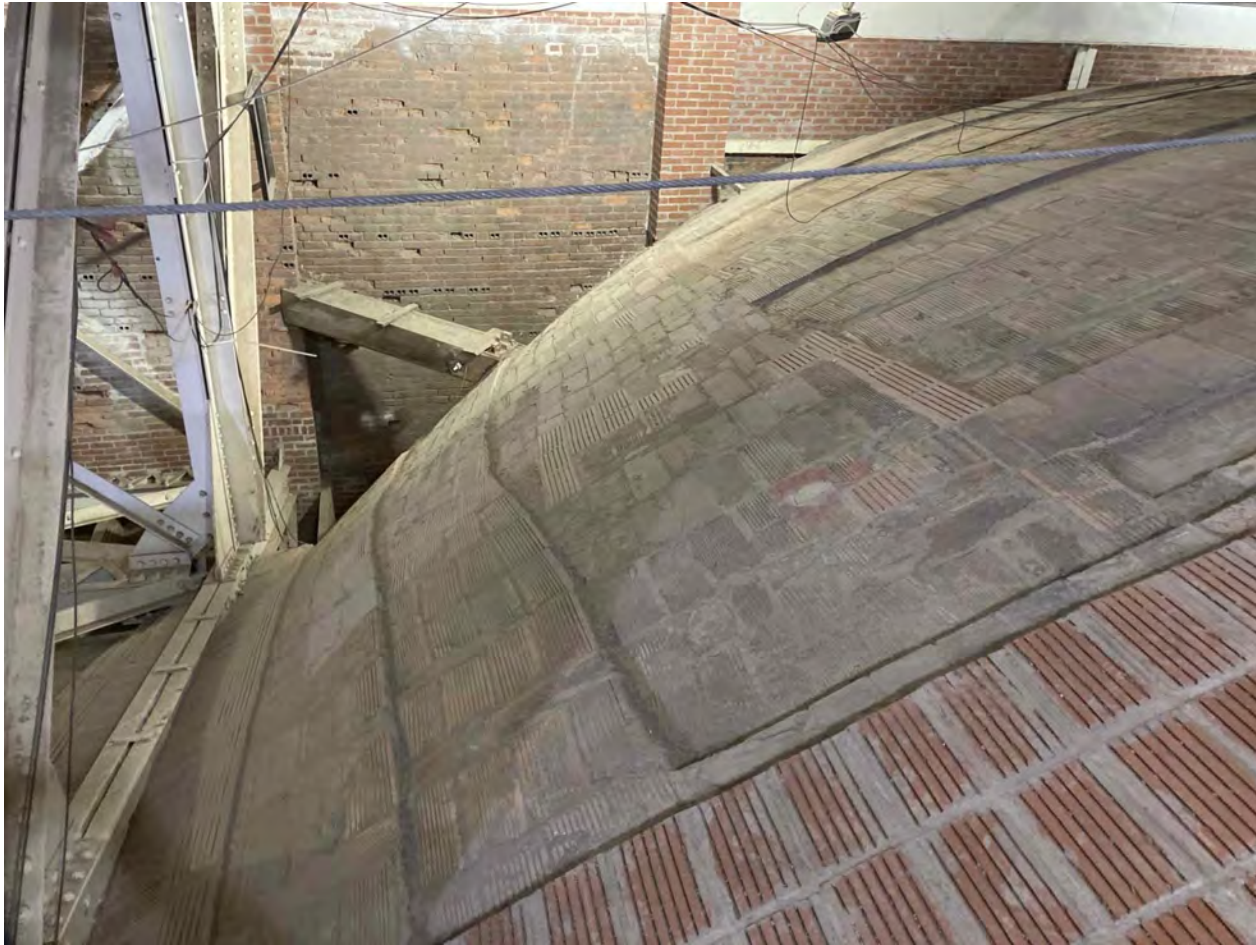
EXTENSIVE AREAS OF REPAIRS

- 7-layers
- Pointing
- Tile replacement
- Pinning
- Structure of the ceiling
